Failure Analysis on a De-NO_x Catalyst of a Large Waste Burner

J. Kuebler^a, R. Baechtold, G. Blugan, K. Lemster, S. Fuso

EMPA, Laboratory for High Performance Ceramics, 8600 Duebendorf, Switzerland

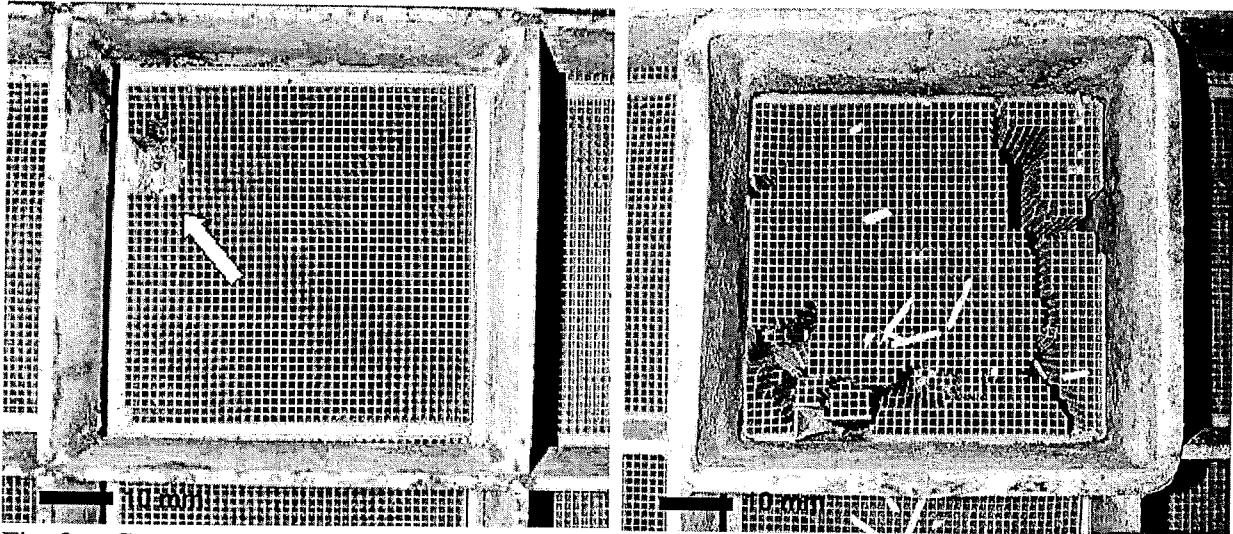
Visual inspection. The visual inspection of the catalyst revealed a large number of defects on the gas entrance and exit faces of elements. Typical defects were photographed and are shown in Fig. 2a and 2b.

Class	Description
Class 1	Free of defects
Class 2	Spalled-off piece $< \varnothing$ 20 mm or a crack
Class 3	More than one defect of Class 2
Class 4	Spalled-off piece $< \varnothing$ 50 mm, see Fig. 2a
Class 5	Combination of defects of Class 2 and 4
Class 6	Spalled-off piece $> \varnothing$ 50 mm
Class 7	Combination of defects of Class 6 and 4 or 2, see Fig. 2b

Fig. 2a: Gas entrance face of an element mounted on a support grid with a clogged up defect (arrow) defined as Class 4.

Fig. 2b: Gas entrance face of a test element in its metal casing with a defect defined as Class 7.

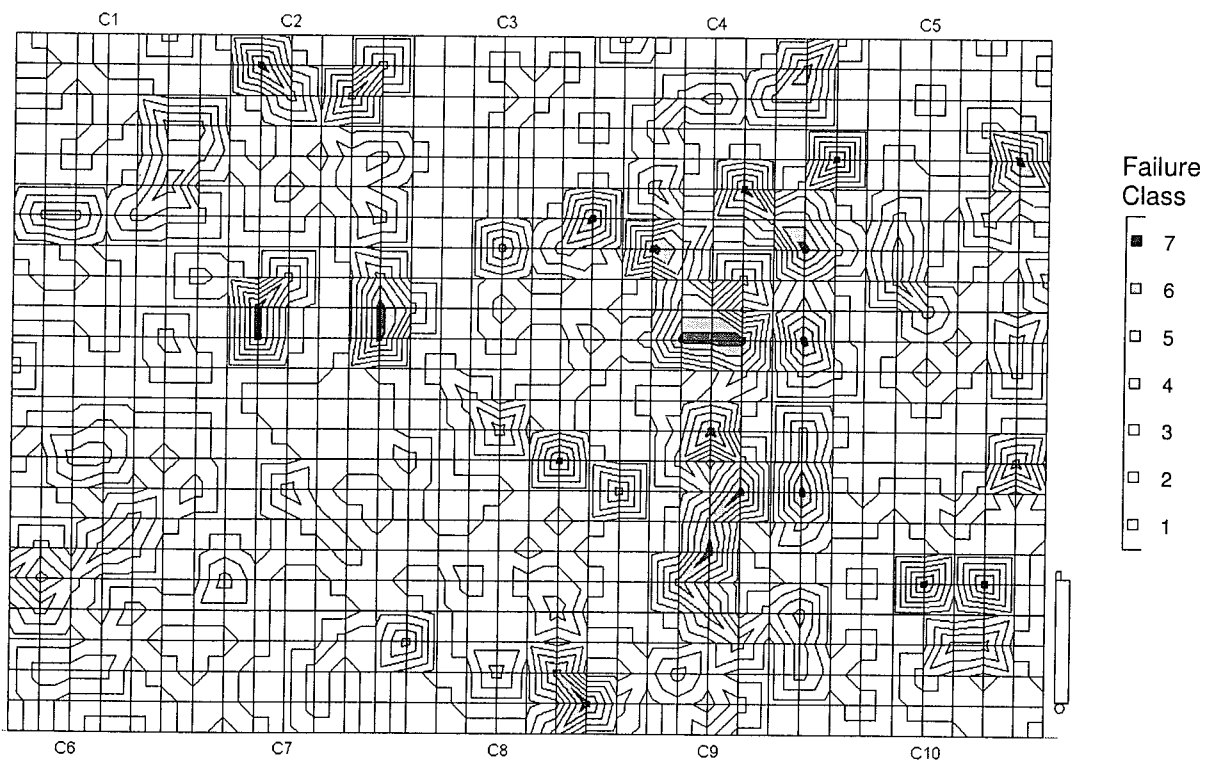
Based on the collected data, a diagram for each gas entrance and exit face of the three element layers was drawn, e.g. Fig. 3. The diagrams showed no significant failure pattern. Therefore, it was concluded that the position of a layer or an element had no important influence on its defect class.

Fig. 3: Diagram for the visualization of defect patterns of a gas entrance or exit face of a complete catalyst element layer. White areas (elements) represent defect Class 1 (defect free) and black areas are rated Class 7. The notations C1 to C10 refer to the module number inside a layer.

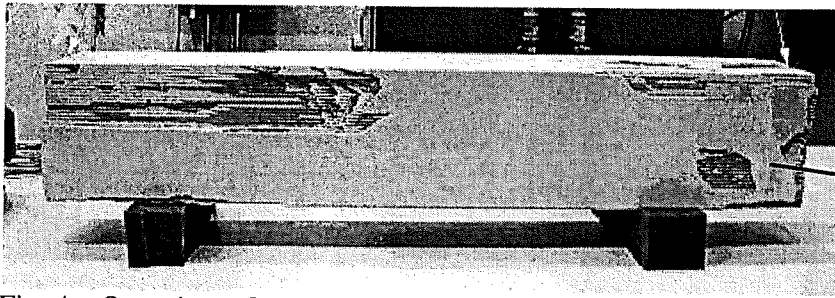
pieces of various sizes had spalled off over almost the entire element length, Fig. 4a. Unused Element B exhibited cracking, with some cracks branching and running over almost its entire length, but no spalled-off pieces were visible, Fig. 5a and 5b.

Fig. 4a: Overview of used Element A. Defects are visible over almost the entire length of ~770 mm.

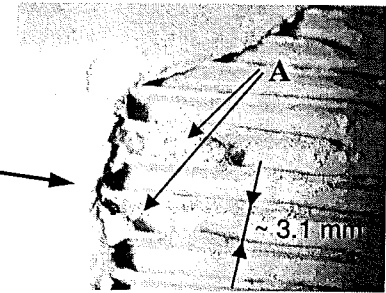
Fig. 4b: Blocked channels (arrow A) beneath spalled-off element skin.

Beneath a spalled-off skin area on Element A, blocked channels were visible, Fig. 4b. This defect could be a result of the cleaning or regeneration processes in which blocked channels are opened by compressed air 3.5 bars and steam at 6 bars.

Chemical analyses by X-ray diffraction (XRD) on used and unused catalyst material revealed no significant differences. Energy dispersive spectroscopy (EDS) analysis of channel obstructions like the one shown in Fig. 4b, showed sulphur, sodium, potassium, titanium, and silicon. The first three elements could not be detected in the unused element material, and therefore they must stem from

the exhaust gas. The fact that titanium and silicon were detected in the obstructions indicates that erosive removal and redeposition of the element material itself, helps to build up blockages.

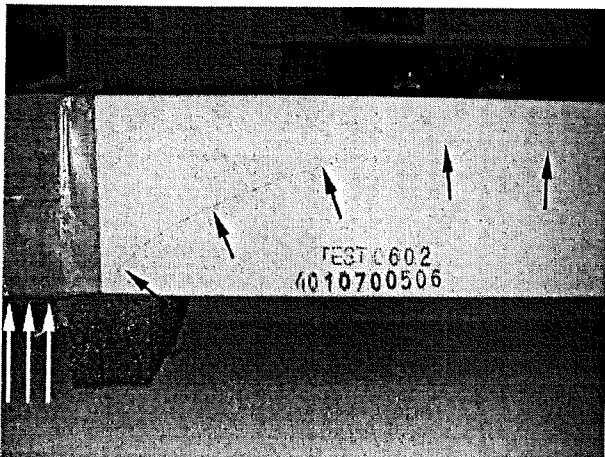
It was noticed that the test elements were cushioned inside their metal casings with ceramic fibre bands fixed in place by tape, Fig. 5a. This kind of mounting is similar to the one of "normal" elements inside their module casings. Therefore, elements stored in a horizontal position experience a force like a bend bar simply due to their own weight. These forces are amplified when the elements are handled or transported. Bearing in mind that the elements are essentially green bodies and have a strength which is typically less than 10 MPa, as measured by Kuebler et al [4], this gives rise to the assumption that instantaneous or sub-critical crack growth due to drying, handling, transport, thermal, cleaning, and regeneration stresses started and enlarged the cracks.

Fig. 5a: Large cracks found on unused Element B (black arrows). The white arrows mark the cushioning between the element and the metal casing.

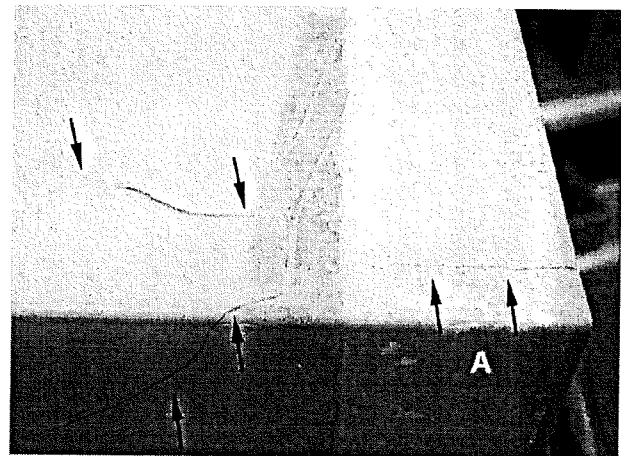
Fig. 5b: Crack starting at an element corner and branching after about 50 mm.

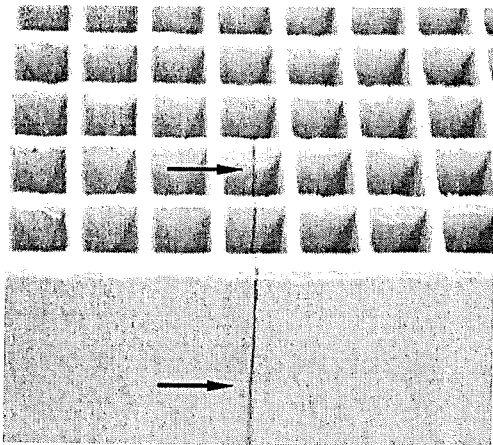
Drying the cubes revealed their high sensitivity to thermal stresses which, in one case, caused a large crack to develop, Fig. 6. This observation was interpreted as a high thermal shock sensitivity of the material / structure.

Fig. 6: Large crack in a cube caused by thermal stresses while drying.

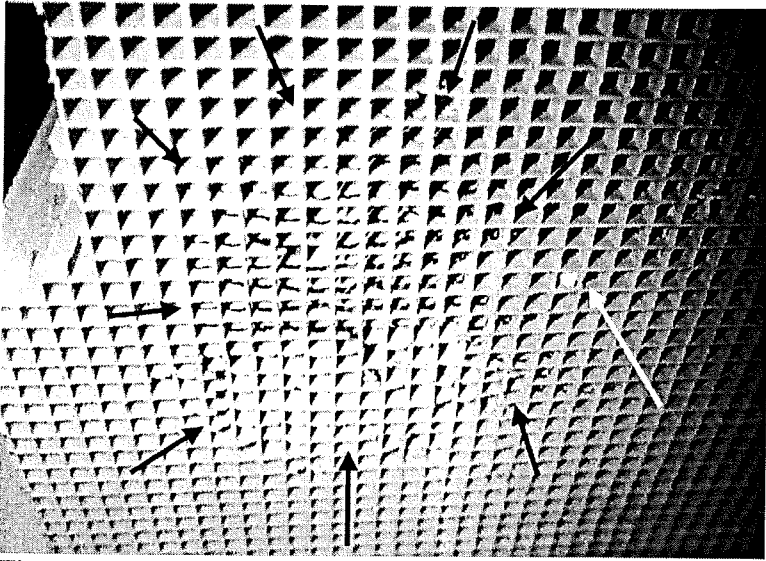
Extrusion defects. When cutting used Element A in half to remove samples for the physical property measurements, a significant extrusion defect almost 60 mm in diameter became visible, Fig.7. The effective dimension of the defect was even larger because the walls around became paper-thin due to an interruption of the feedstock flow during extrusion.

Fig. 7: Large material separation in Element A resulting from a feedstock flow interruption during extrusion (black arrows). The white arrow mark a blocked channel located almost in the centre of the element.

The main reason why pieces from the catalyst elements were spalling off was the significant number of large extrusion defects resulting from interruptions of the flow of the feedstock during extrusion. These defects are starting-points for cracks. Different driving forces, e.g. vibration during transport and thermal stresses during operation were responsible for further spontaneous and sub-critical crack growth, sometimes up to hundreds of millimetres in length.

- Optimize the feedstock and extrusion process to eliminate extrusion defects which are the starting-points for cracks;
- Optimize handling and transport of the elements to suppress instant and sub-critical crack growth;
- Eliminate steam from the regeneration procedure because it reduces the structural strength by 50 % and can degrade strength permanently;
- Enlarge the cross-section of the channels to reduce the build up of blockages and make the walls thicker to increase the local strength of the structure.

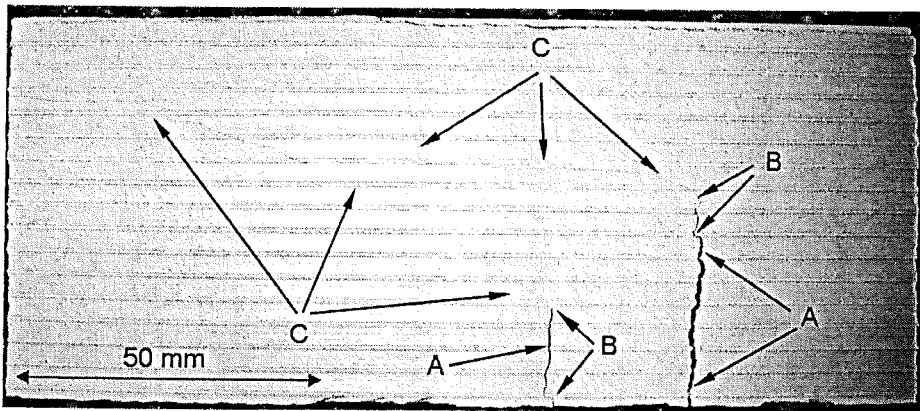
During inspection of failed elements from the compressive tests, many similar large defects were seen. Cracks started to grow from these defects first in the transversal and, after deflection, in the longitudinal direction, Fig. 8a. Additionally, small transversal cracks in channel walls were present, Fig. 8b. As stated earlier, the driving forces for starting and advancing cracks in unused elements are drying, handling, transport, and mechanical stresses.

Fig. 8a: Failed segment from compressive test Cube 1 (rel. hum. 41%).
 A) Defects due to interrupted feedstock flow during extrusion.
 B) Cracks starting in transversal direction.
 C) Cracks deflecting in longitudinal direction.

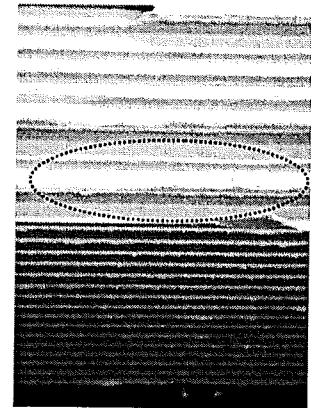
Fig. 8b: Small transversal cracks in channel wall of width 3.1 mm.

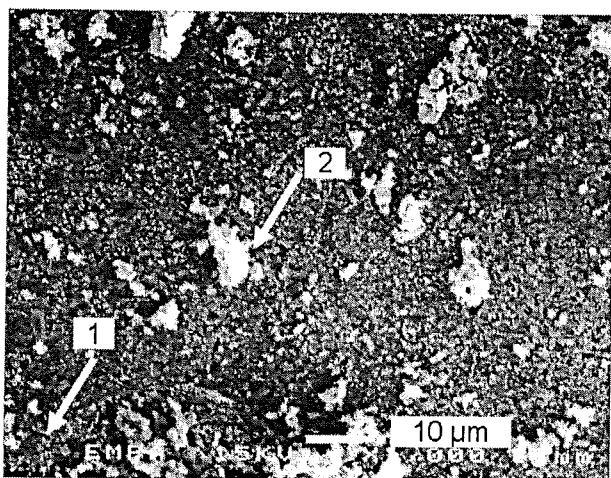
Microstructural and chemical analysis. To complete the failure analysis, microstructural (optical and scanning-electron microscopy) and chemical analyses were performed. SEM images showed that the cleaning process with hot steam, probably in combination with exhaust gas particles, has an erosive effect on the catalyst element structure. Further, it could be shown that micro-cracks are present in the channel walls of both the used and unused elements, Fig.9a and 9b.

Fig. 9a: Surface of channel wall in Element A:
1) micro-crack; 2) particles from exhaust gas.

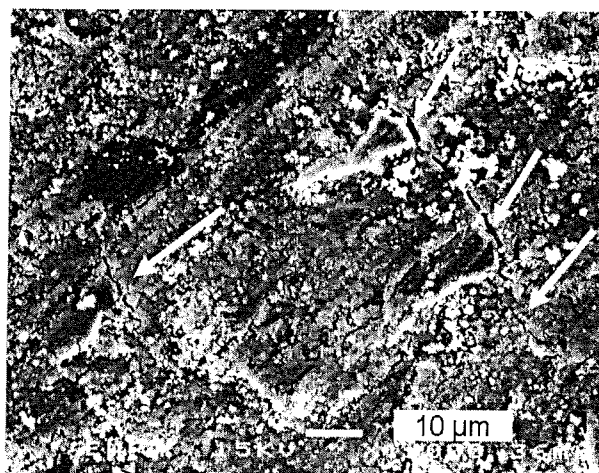
Fig 9b: Surface of channel wall in Element B.
The arrows mark micro-cracks.
