Failure Analysis on a De-NO_x Catalyst of a Large Waste Burner

J. Kuebler^a, R. Baechtold, G. Blugan, K. Lemster, S. Fuso

EMPA, Laboratory for High Performance Ceramics, 8600 Duebendorf, Switzerland

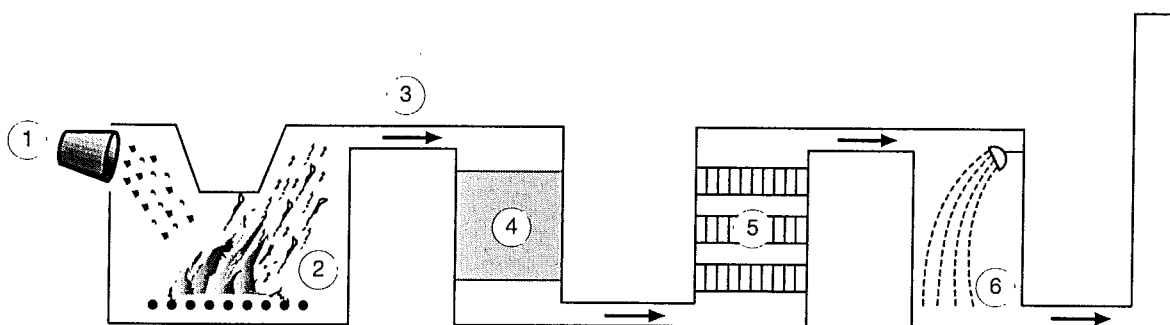
Fig. 1: Diagram of waste burner: 1) waste, 2) incinerator, 3) exhaust gas, 4) electrostatic filter for large particles, 5) NO_x catalyst with three layers of elements, 6) washer for small particles, 7) cleaned air.
